DEPARTMENT OF TRANSPORTATION

Contract #: 04-0120F4Cty: SF/ALA Rte: 80 PM: 13.2/13.9File #: 70.28**WELDING INSPECTION REPORT****Resident Engineer:**Pursell, Gary**Address:** 333 Burma Road**City:** Oakland, CA 94607**Report No:** WIR-002689**Date Inspected:** 15-May-2008**Project Name:** SAS Superstructure**OSM Arrival Time:** 900**Prime Contractor:** American Bridge/Fluor Enterprises, a JV**OSM Departure Time:** 1900**Contractor:** Japan Steel Works**Location:** Muroran, Japan**CWI Name:** Tomio Imai**CWI Present:** Yes No**Inspected CWI report:** Yes No N/A**Rod Oven in Use:** Yes No N/A**Electrode to specification:** Yes No N/A**Weld Procedures Followed:** Yes No N/A**Qualified Welders:** Yes No N/A**Verified Joint Fit-up:** Yes No N/A**Approved Drawings:** Yes No N/A**Approved WPS:** Yes No N/A**Delayed / Cancelled:** Yes No N/A**Bridge No:** 34-0006**Component:** Tower, Jacking and Deviation Saddles**Summary of Items Observed:**

West Deviation Saddle Casting W2-E1

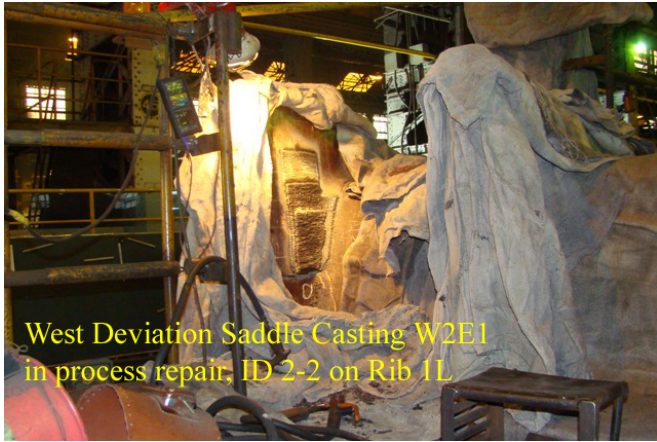
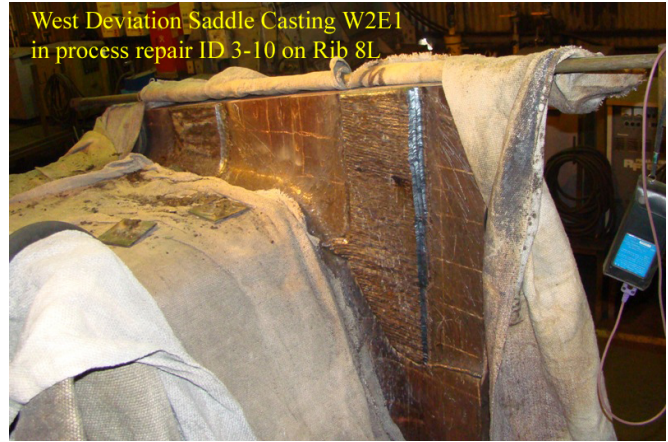
On this date the QA representative Joe Lanz arrived at Japan Steel Works (JSW) of Muroran Japan and traveled to JSW foundry, escorted by JSW representative Mr. Yoshihiro Itoh, to monitor the in process casting repair welding on West Deviation Saddle casting W2-E1. The welding was performed to build up the thickness of the ribs in areas that were found to not meet the minimum thickness of the contract special provisions. The repair locations and repair details for this casting were submitted as number 000643, revision 02. The JSW welding personnel Mr. Noritake Tamuri, identified as number 93-2337 continued the in process repair welding of Rib 8L, repair 3-10,

location I-5 and Mr. Kozuya Komai, identified as number 06-8002 continued the in process repair welding of Rib1L, repair 2-2 location B-8 with both utilizing the Shielded Metal Arc Welding (SMAW) process per the welding procedure specification (WPS) SJ 3026-2. The welding was performed in the 2G (Horizontal) position. The filler metal utilized was identified as 5mm diameter, Class E10016-G, Brand name LB-106. The welding parameters and heat control were monitored by Nikko Inspection Services Quality Control (QC) Mr. Imai at periodic intervals of approximately 1.5 hours. The minimum preheat temperature of 150 degrees Celsius and maximum interpass temperature of 260 degrees Celsius was verified to meet the WPS requirements by Mr. Imai. The SMAW welding average amperage and voltage by clamp type meter and travel speed were verified to be within the welding procedure specification parameter range of 180 amps to 240 amps, 22 volts to 26 volts and travel speed of 115 to 280 mm per minute by the QA inspector. The repair on rib 8L, number 3-10 length is 1,110 mm, width is 615 mm and maximum depth is 36 mm with a volume 24,576 cubic centimeters and repair on rib 1L, number 2-2 length is 1,275 mm, width is 615 mm and maximum depth is 30 mm with a volume 23,524 cubic centimeters. The work was not completed on this date and appears to meet the minimum requirements of the welding procedure specification and contract documents.

The following digital photographs illustrate observations of the activities being performed.
